Long Term Environmental Management Plan

1 Sirius Road, Lane Cove West, NSW

9 November 2020

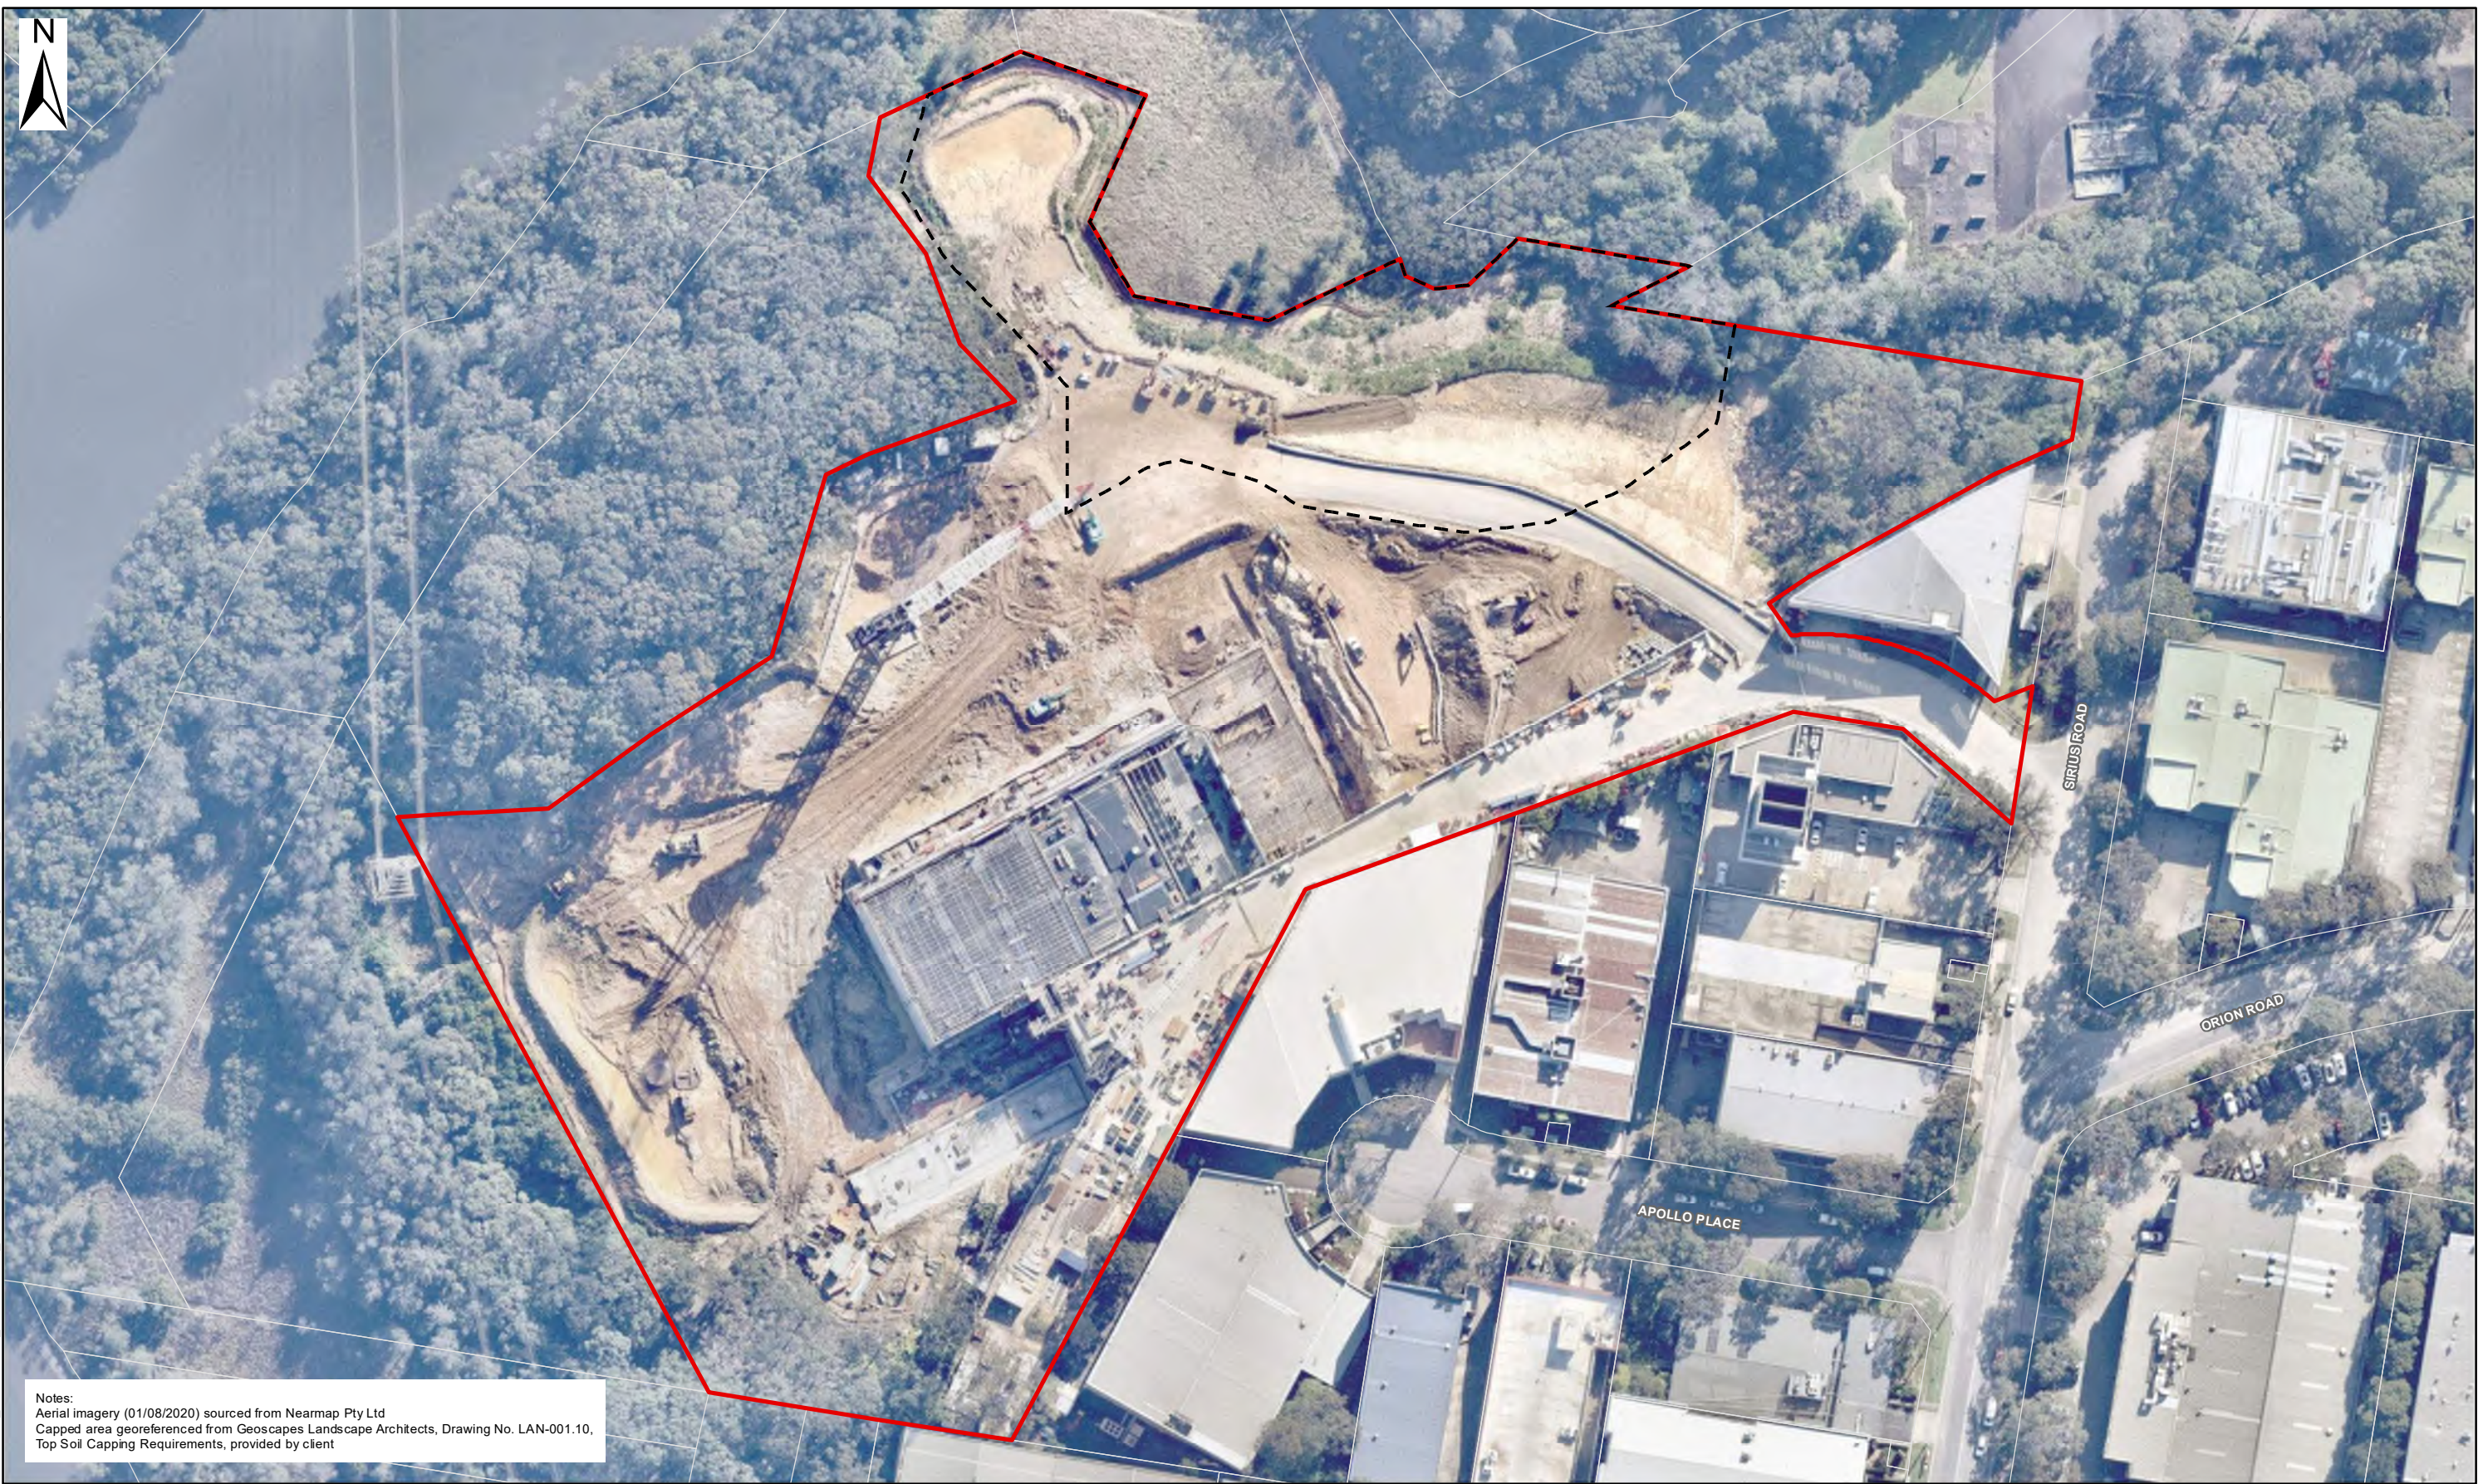
Figure No:	2
Title:	Site Layout
Project:	Long Term Environmental Management Plan
Location:	1 Sirius Road, Lane Cove West
Client:	AirTrunk Pty Ltd

Notes:
Aerial imagery (01/08/2020) sourced from Nearmap Pty Ltd
Capped area georeferenced from Geoscapes Landscape Architects, Drawing No. LAN-001.10,
Top Soil Capping Requirements, provided by client

Potential Contaminated Media	Location
Contaminated soil within capped area	Northern portion of the site illustrated on Figure 2 and Figure 3
Contaminated groundwater	Migrating in a northerly direction underneath the site
Ground gases within the former landfill materials	Northern portion of the site illustrated on Figure 2 and Figure 3

This LTEMP applies to the whole site, but more specifically to the area of the site where contaminated materials are retained under the site surface in the capped area, as illustrated on **Figure 2** and **Figure 3**.

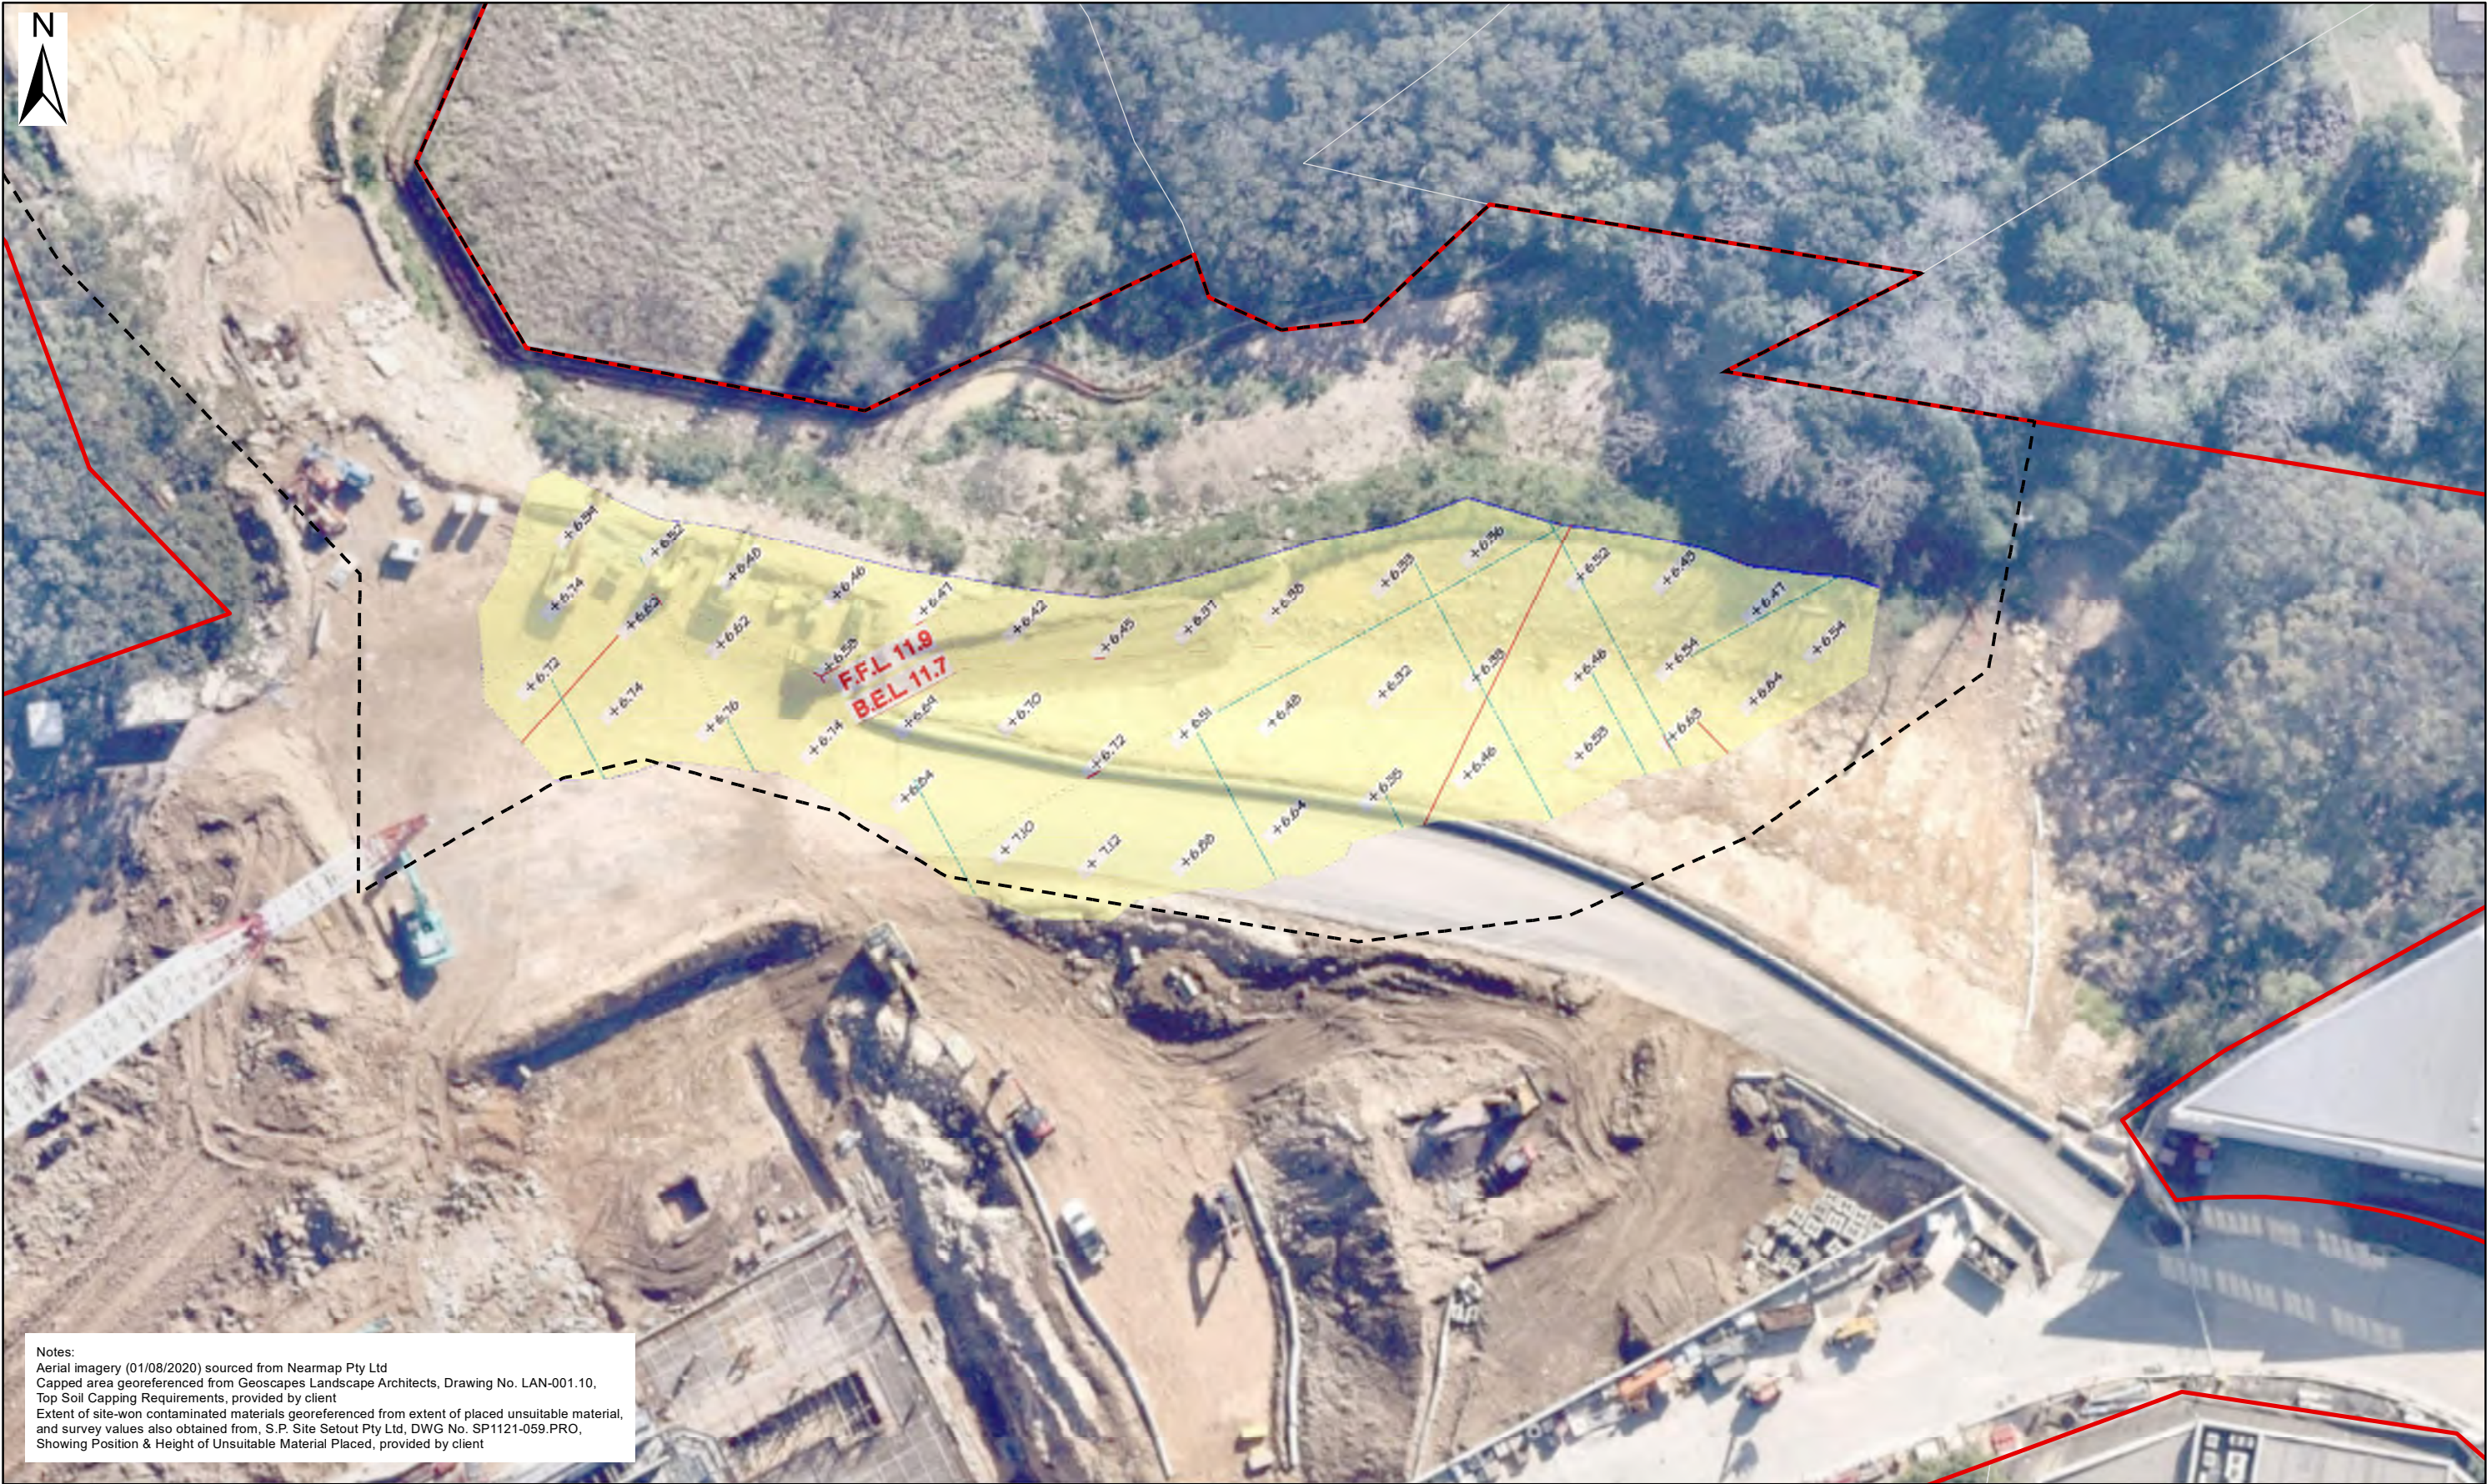
Figure No:	3a
Title:	Surveyed Top of Site-Won Contaminated Materials
Project:	Long Term Environmental Management Plan
Location:	1 Sirius Road, Lane Cove West
Client:	AirTrunk Pty Ltd

Notes:
Aerial imagery (01/08/2020) sourced from Nearmap Pty Ltd
Capped area georeferenced from Geoscapes Landscape Architects, Drawing No. LAN-001.10,
Top Soil Capping Requirements, provided by client
Extent of site-won contaminated materials georeferenced from extent of placed unsuitable material,
and survey values also obtained from, S.P. Site Setout Pty Ltd, DWG No. SP1121-059.PRO,
Showing Position & Height of Unsuitable Material Placed, provided by client

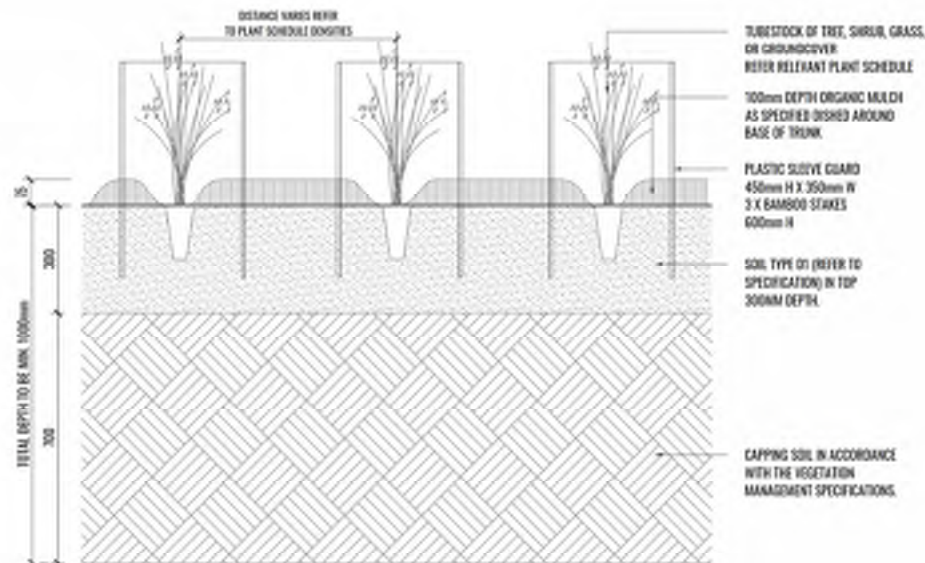
01 SECTION TYPICAL TUBESTOCK REVEGETATION PLANTING DETAIL IN CONTAMINATED AREAS
SCALE 1:10

NOTE: ALL REVEGETATION PLANTING MUST BE IN ACCORDANCE WITH THE VEGETATION MANAGEMENT SPECIFICATIONS AS PREPARED BY TRAVERS ECOLOGY
REFER TO DOCUMENT REF: TRAVERS IN REVEG AREAS STEEPER THAN 1:4 EROSION CONTROL MATTING SHOULD BE USED WITHOUT MULCH

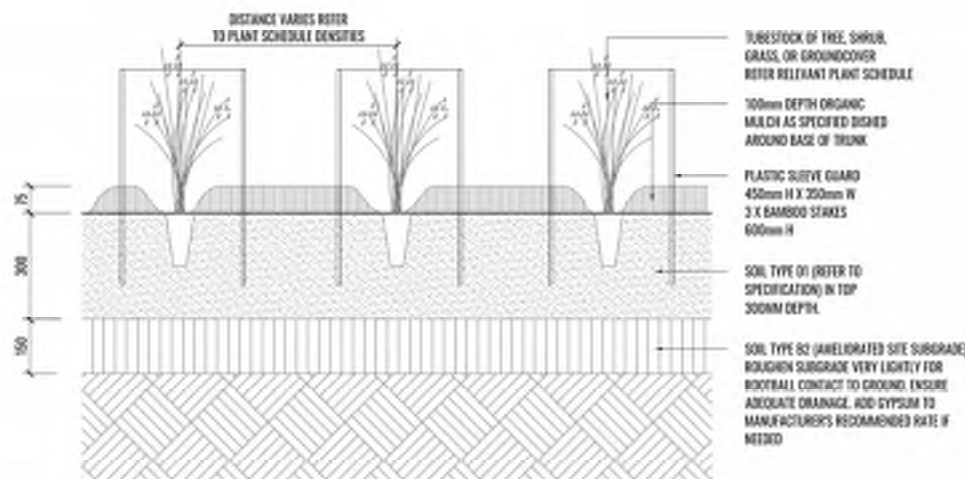
02 SECTION TYPICAL TUBESTOCK REVEGETATION PLANTING DETAIL IN NON-CONTAMINATED AREAS
SCALE 1:10

NOTE: ALL REVEGETATION PLANTING MUST BE IN ACCORDANCE WITH THE VEGETATION MANAGEMENT SPECIFICATIONS AS PREPARED BY TRAVERS ECOLOGY
REFER TO DOCUMENT REF: TRAVERS IN REVEG AREAS STEEPER THAN 1:4 EROSION CONTROL MATTING SHOULD BE USED WITHOUT MULCH
