# Asbestos Management Plan

1 Sirius Road, Lane Cove West, NSW

24 October 2025

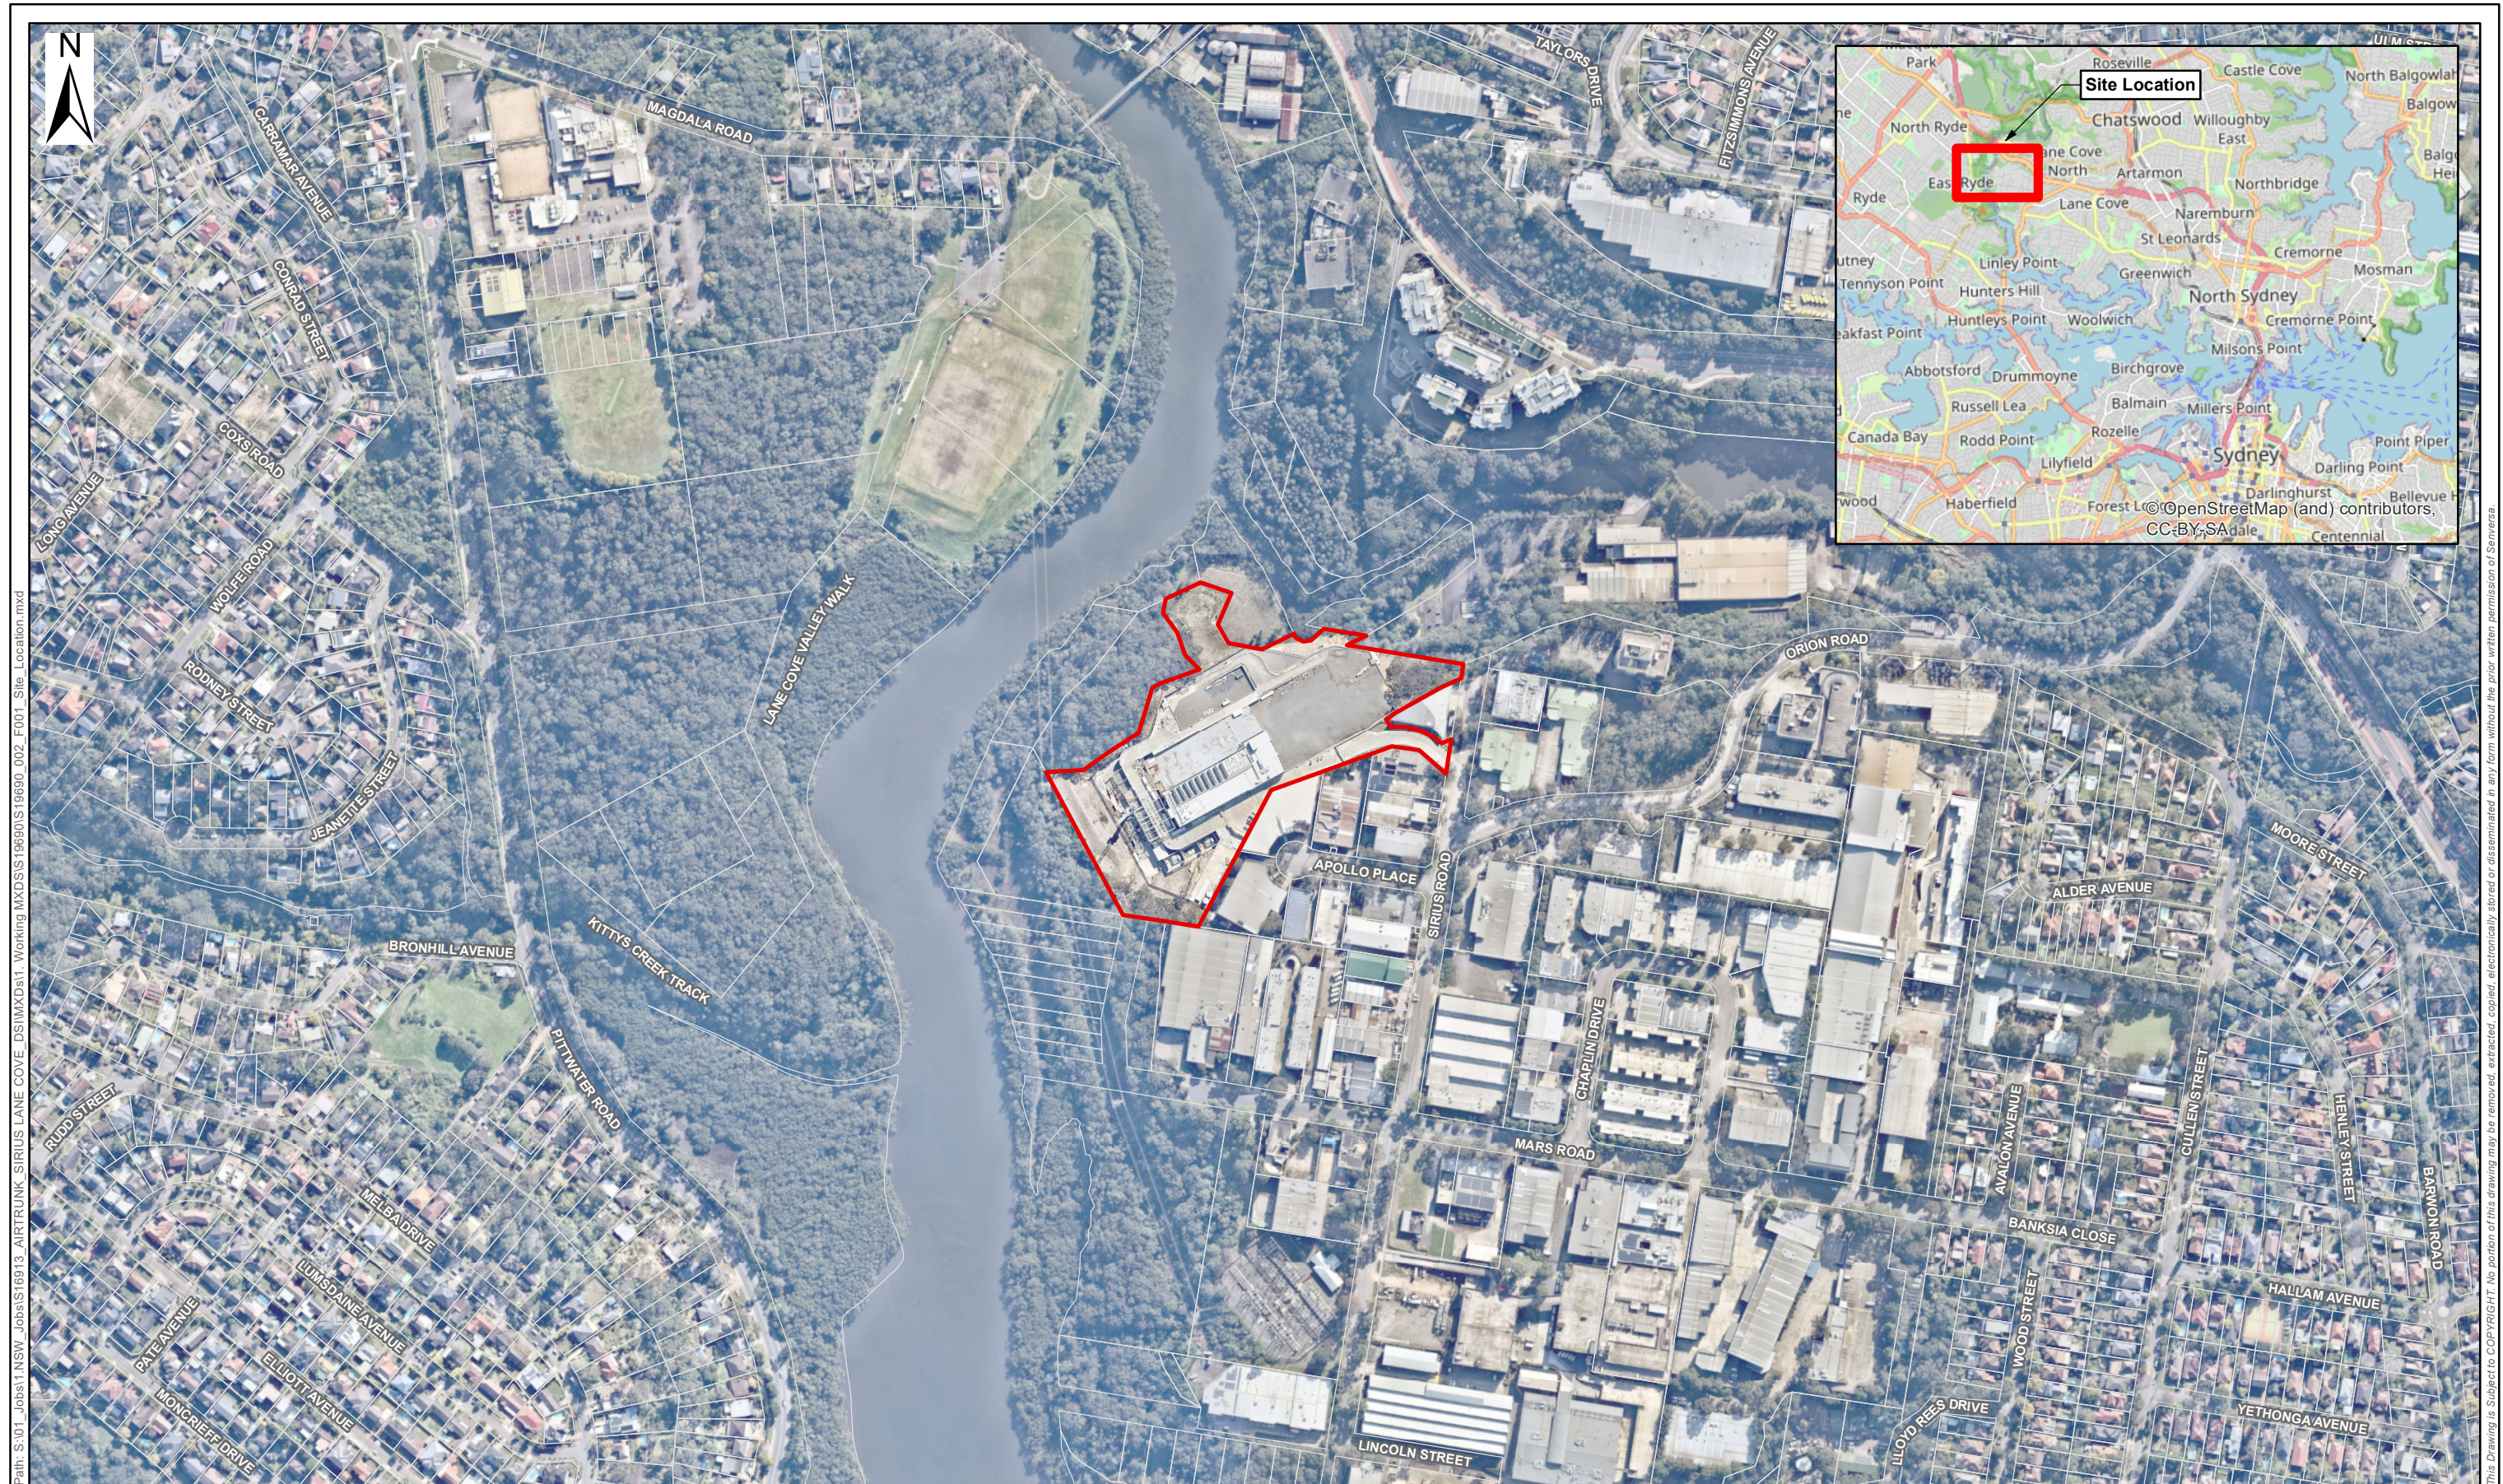
Figure 4: Capped Area

A section of this site in its northern portion and within the Stage 2 area, is an historical containment cell regulated by the NSW EPA under a Maintenance of Remediation Notice issued under the *Contaminated Land Management Act 1997*. Stage 1 work included adding soils excavated as part of construction works, and contaminated with asbestos containing materials (ACM), above the containment cell and covering with a marker layer and a capping layer of clean material. The historical containment cell and the newly placed material are indicated on **Figure 4**.

The placement area is indicated on **Figure 4**. Further details on the type and extent of asbestos are also included in the EMP which should be referred to in conjunction with this document; however, the material is described as:

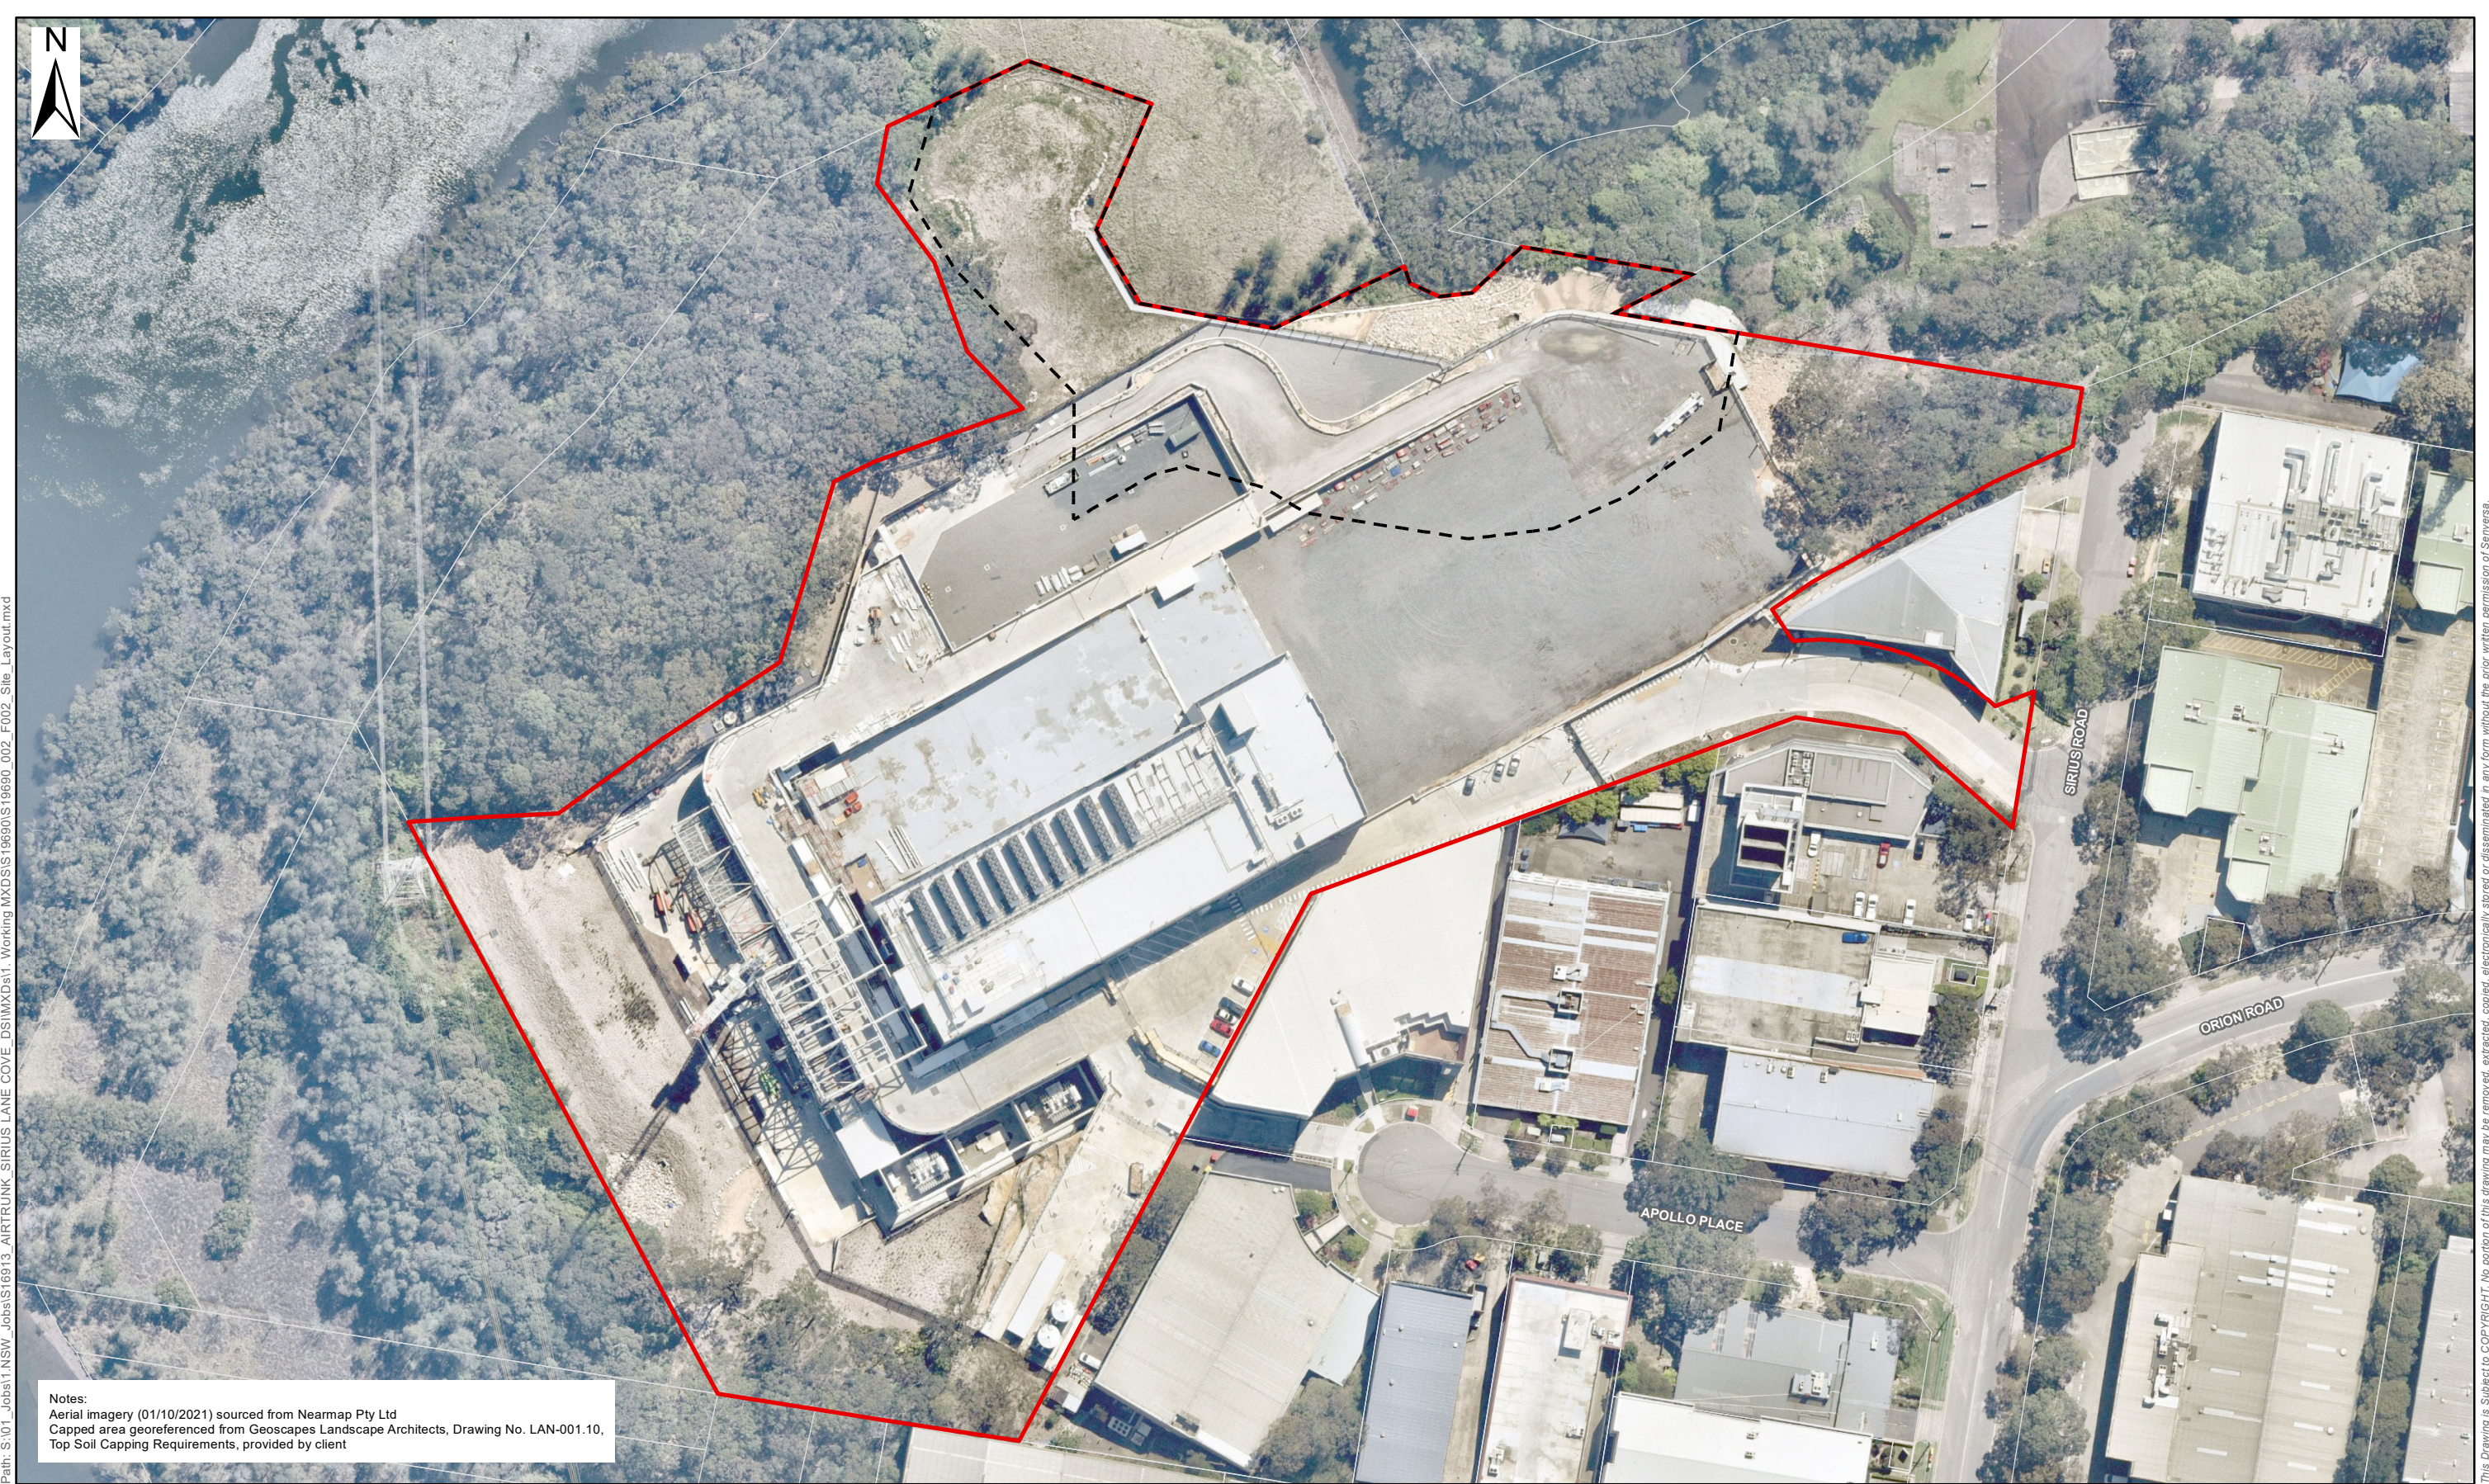
Figure 3: Stage Boundaries

Notes:  
Aerial imagery (01/10/2021) sourced from Nearmap Pty Ltd  
Capped area georeferenced from Geoscapes Landscape Architects, Drawing No. LAN-001.10,  
Top Soil Capping Requirements, provided by client

Stage 1 and Stage 2 are indicated on **Figure 3**. This document relates to work being undertaken on Stage 2 only.

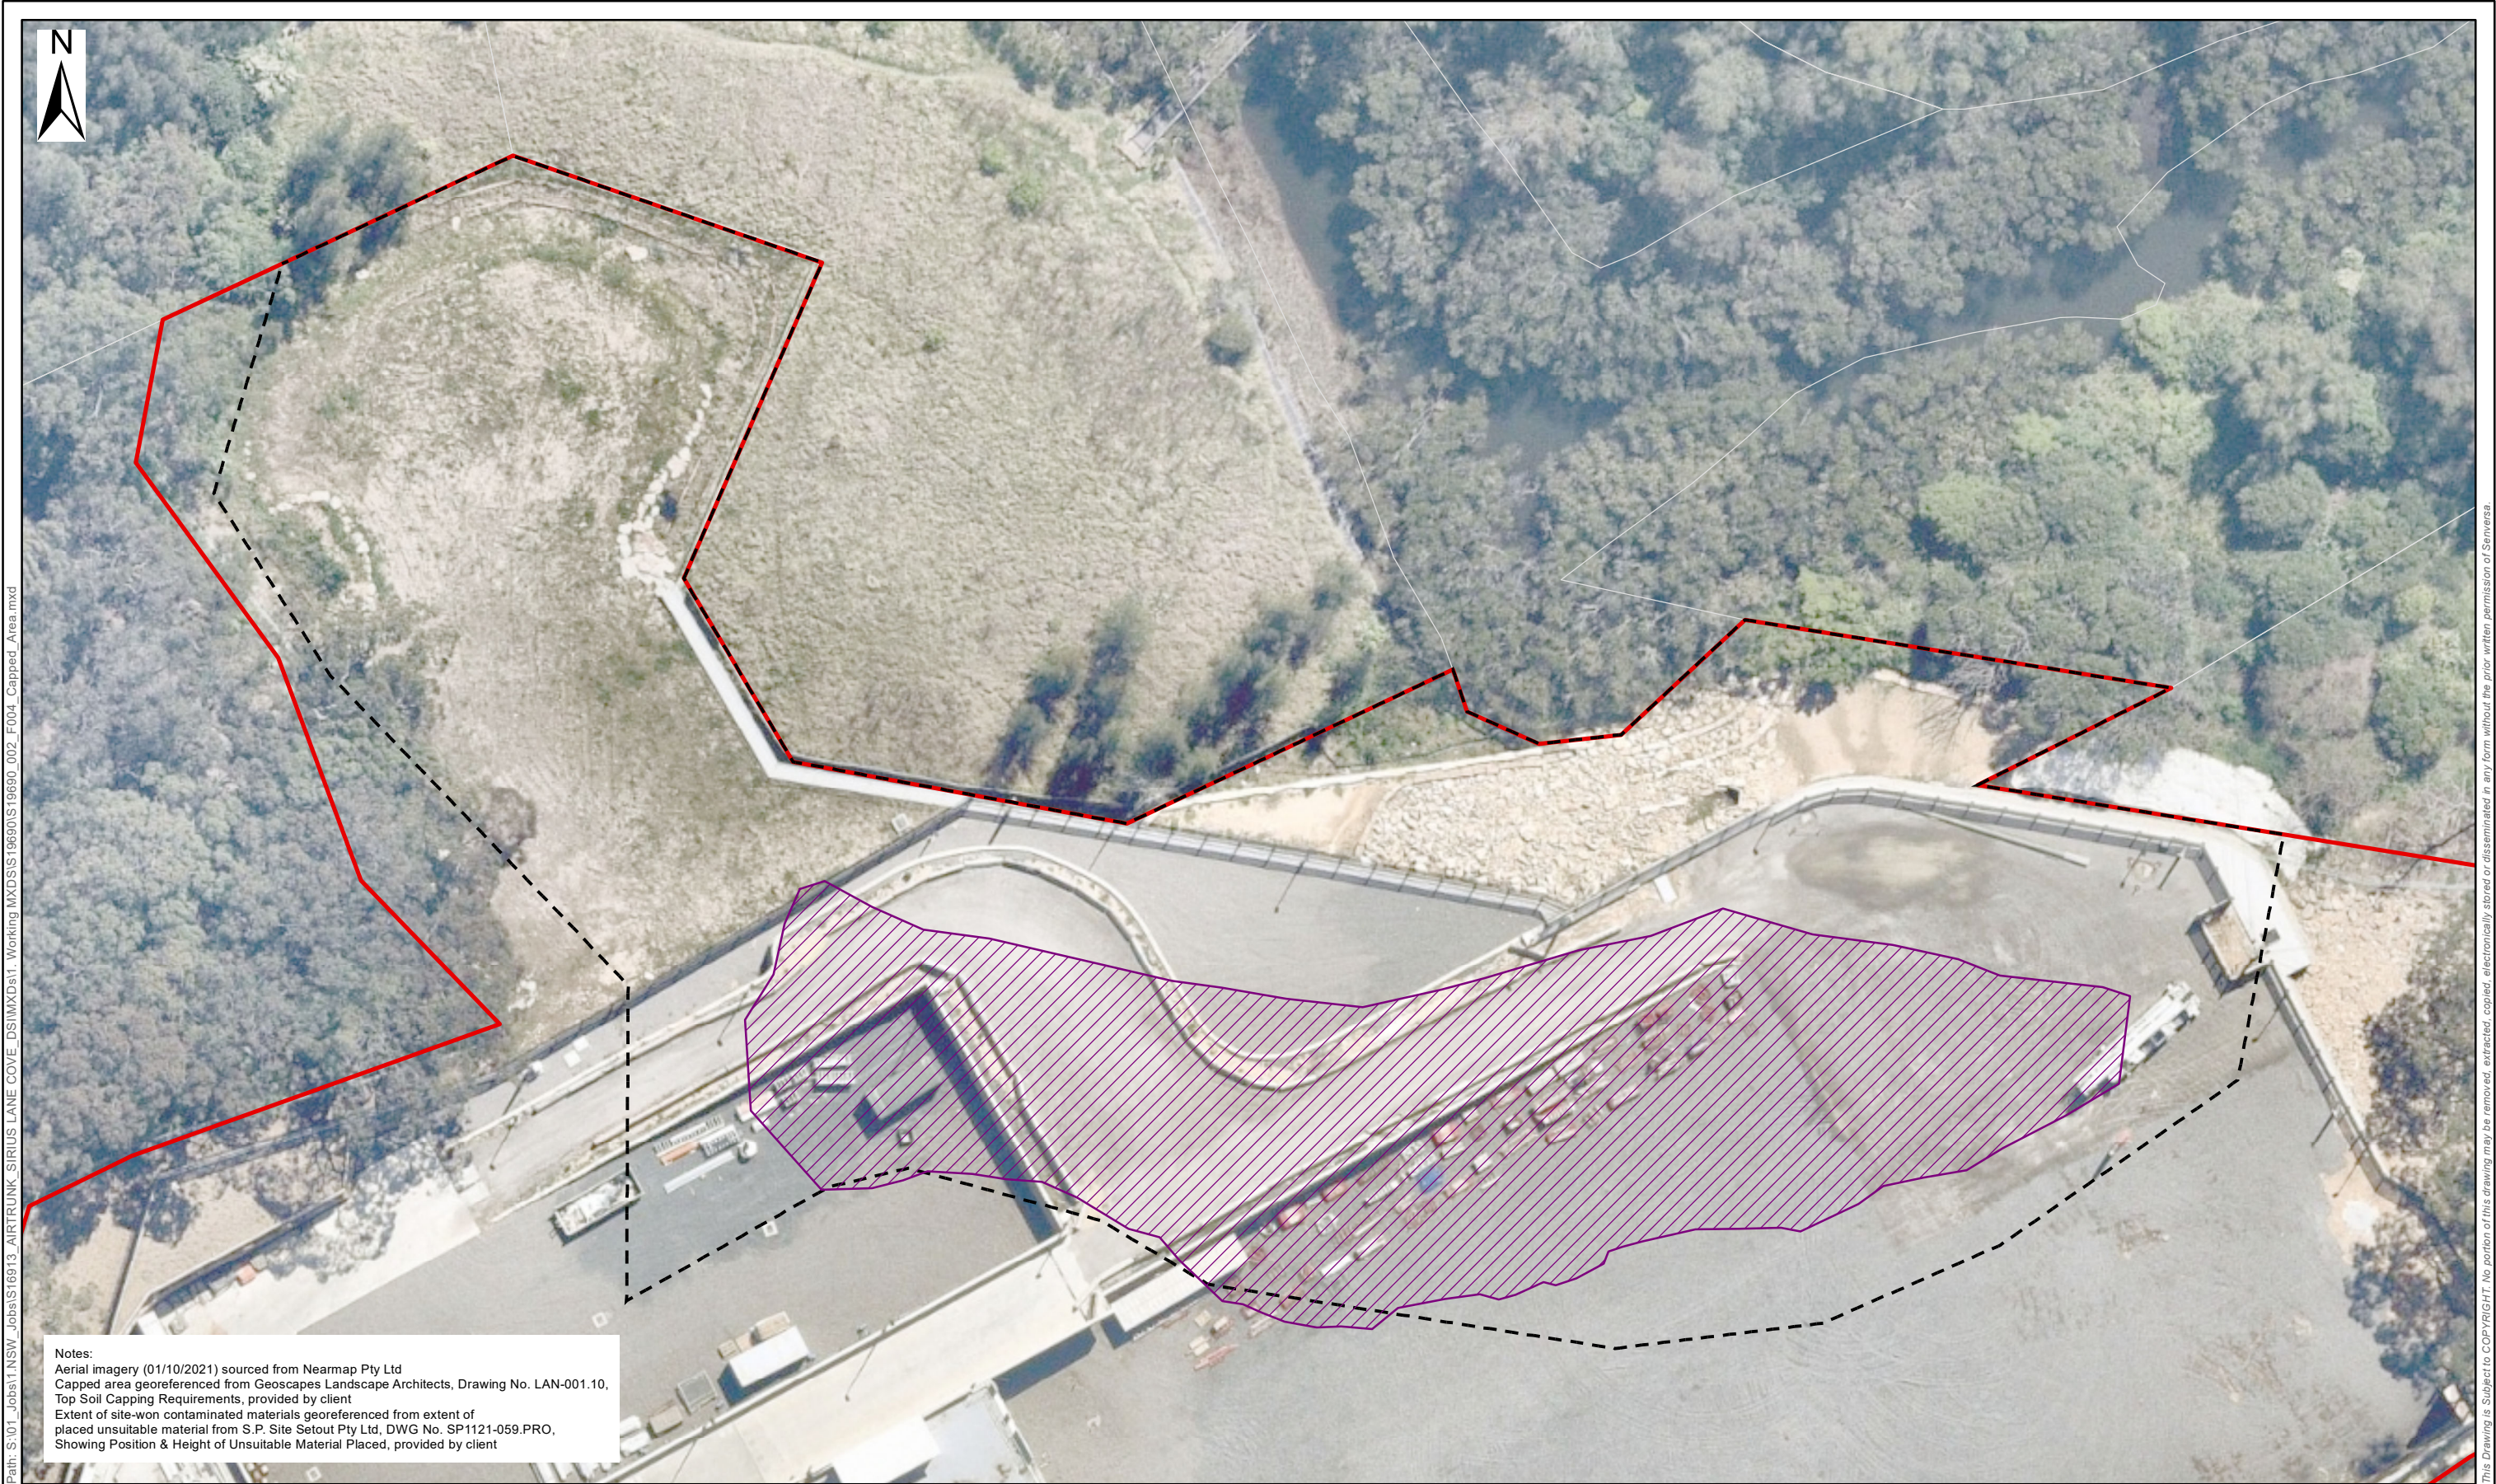
Notes:  
Aerial imagery (01/10/2021) sourced from Nearmap Pty Ltd  
Capped area georeferenced from Geoscapes Landscape Architects, Drawing No. LAN-001.10,  
Top Soil Capping Requirements, provided by client  
Extent of site-won contaminated materials georeferenced from extent of  
placed unsuitable material from S.P. Site Setout Pty Ltd, DWG No. SP1121-059.PRO,  
Showing Position & Height of Unsuitable Material Placed, provided by client

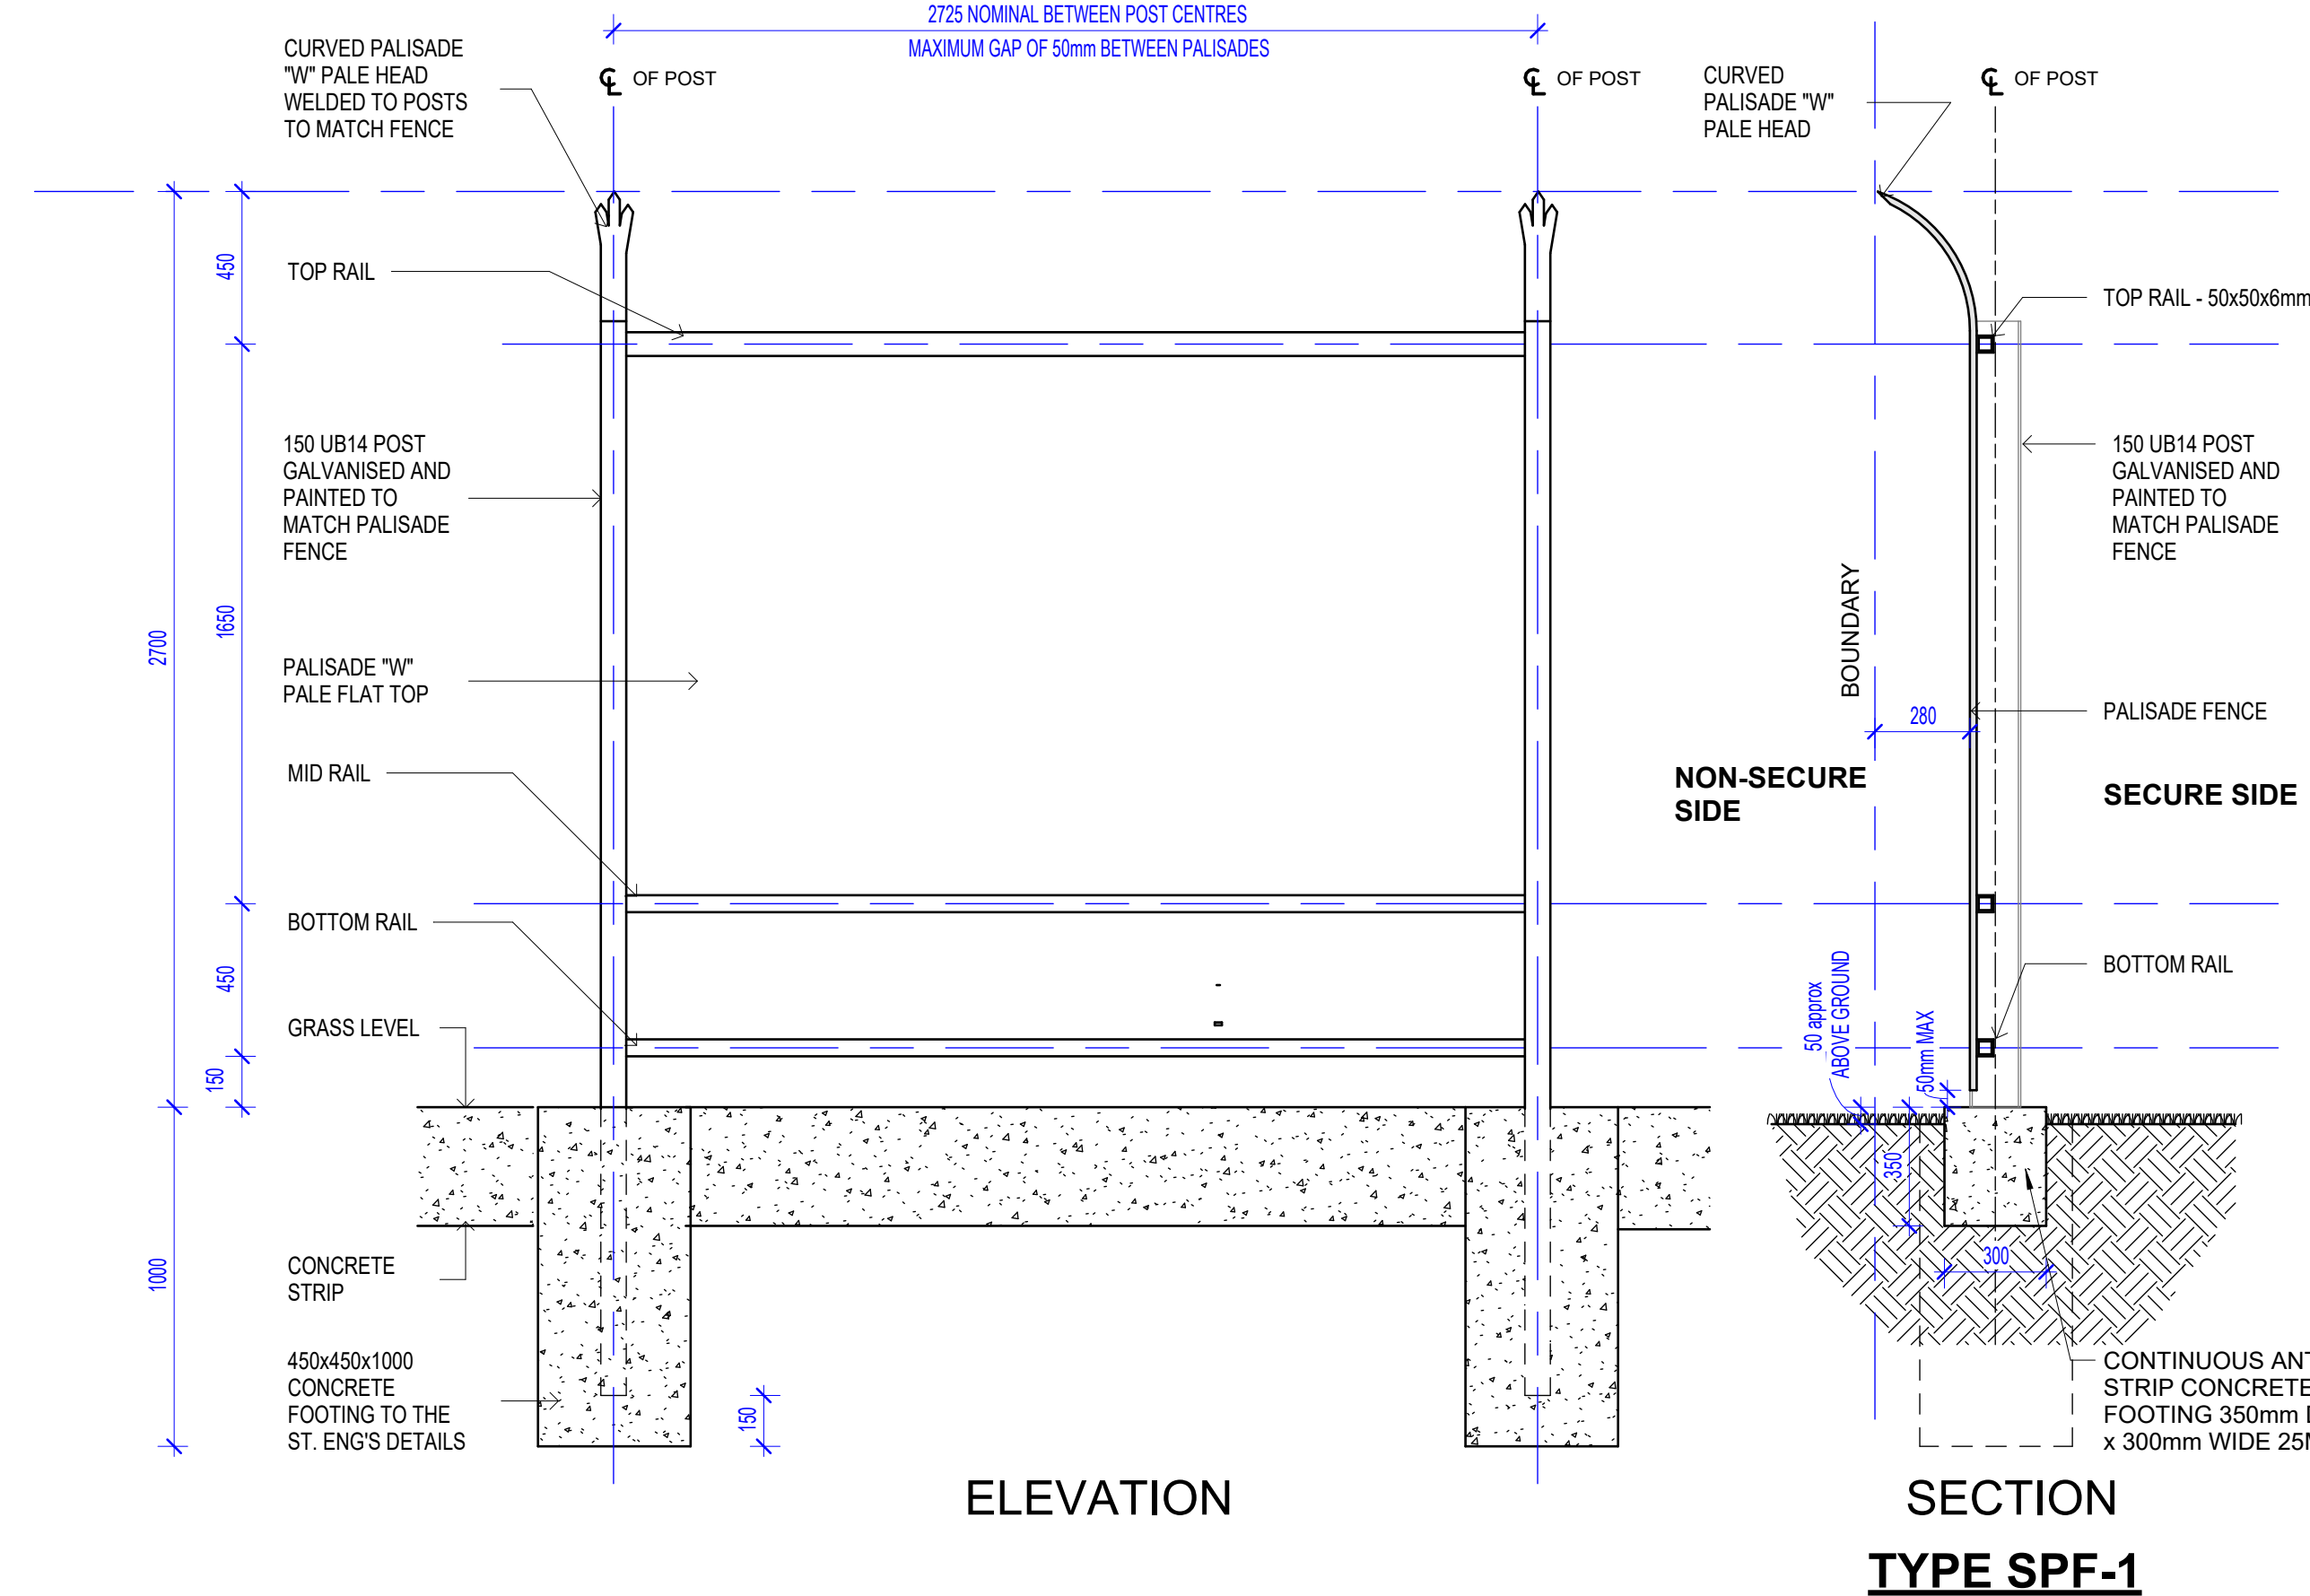
2 TYP. CURVED SECURITY PALISADE FENCE (SPF-1) TO LANDSCAPE AREAS - CC  
1:20

SECURITY PALISADE FENCE	
CODE	DESCRIPTION
SPF-1	2.7m HIGH BLACK CURVED SECURITY PALISADE FENCE AT LANDSCAPE AREAS (SEE DETAIL 2/A-20/09)
SPF-6	2.7m HIGH BLACK STRAIGHT SECURITY PALISADE FENCE ON TOP OF CONCRETE UPSTAND/SLAB
