Vegetation Management Plan

Amendments to
SSD Approval SSD-9741
(Section 4.55 Application)
Lot 1, DP1151370
1 Sirius Road
Lane Cove West

January 2020
(REF: 18AWE02UV)

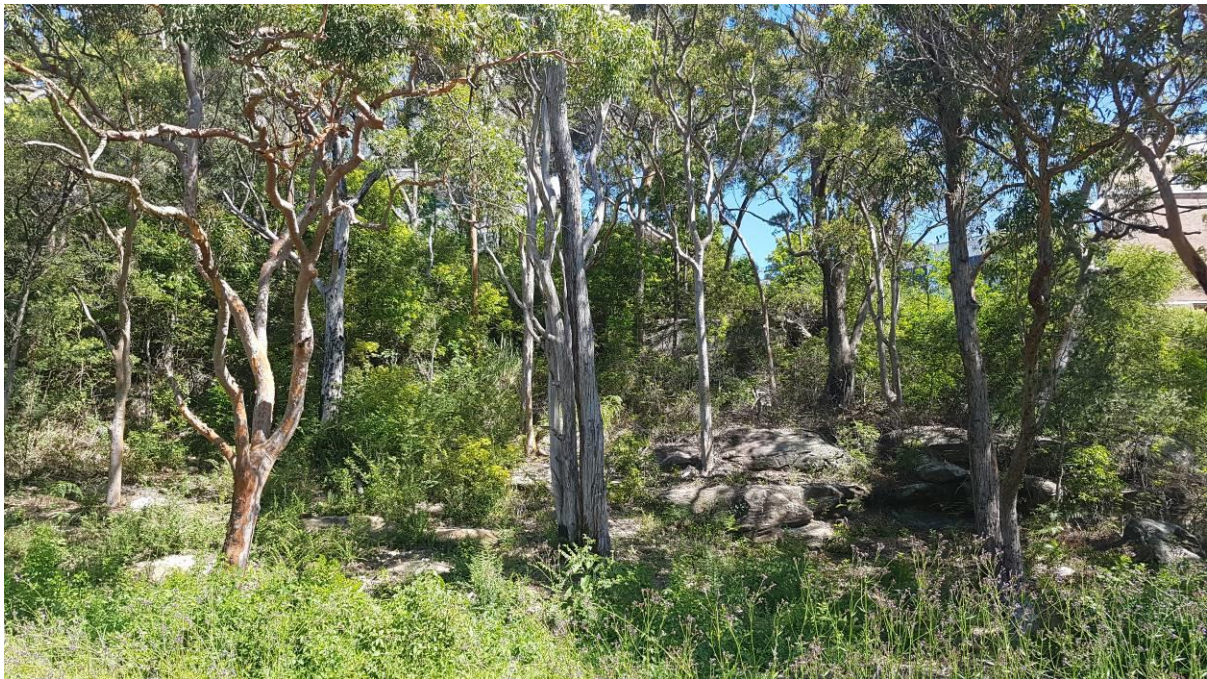
Photo 1 – Smooth-barked Apple - Red Bloodwood open forest (PCT 1776) in the north-eastern corner of the site.

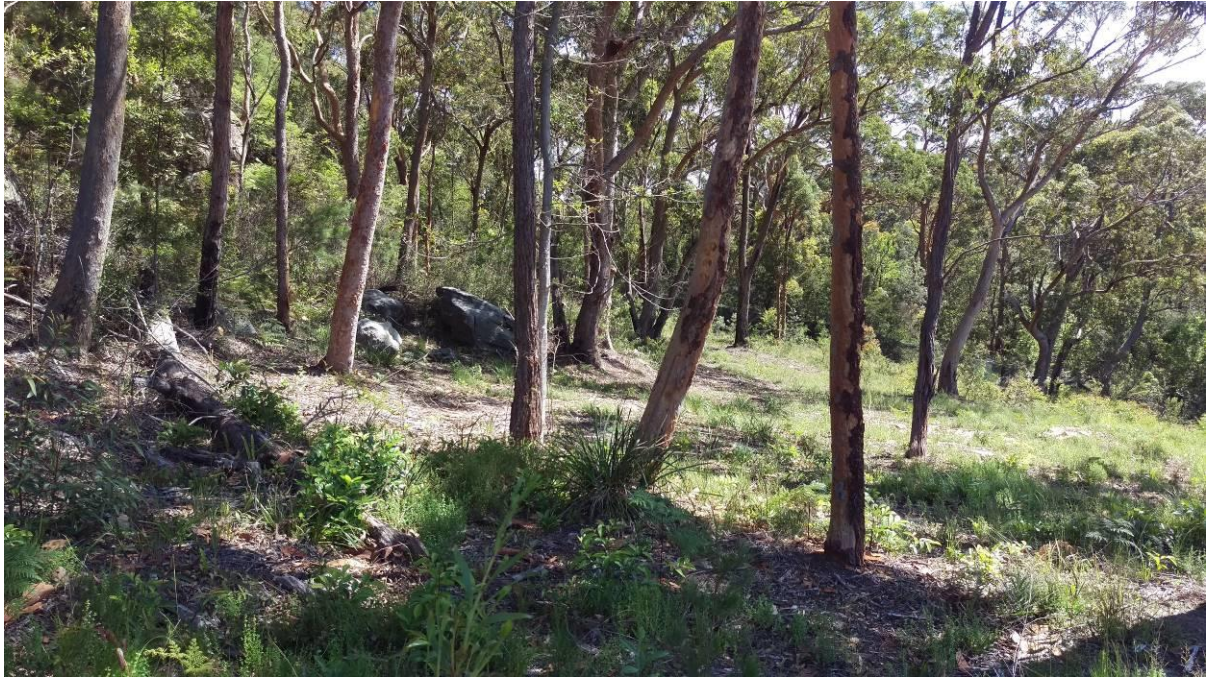
Photo 2 – Smooth-barked Apple - Red Bloodwood open forest (PCT 1776) in the southern corner of the site.

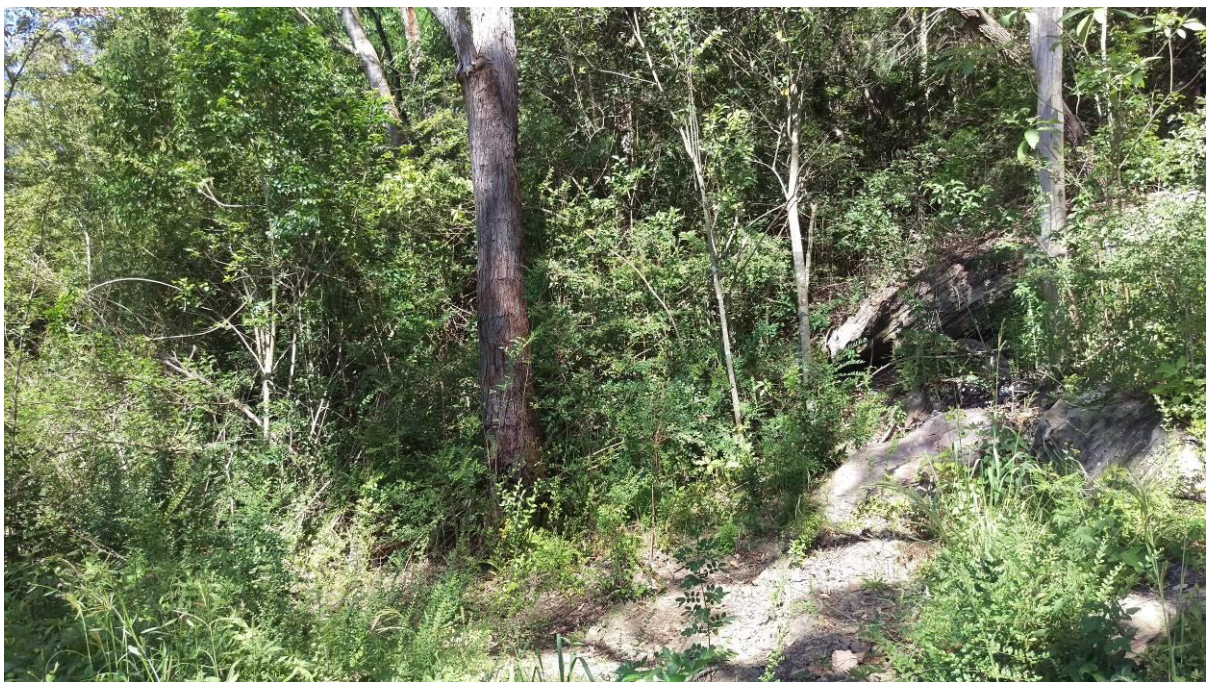
Photo 3 – Smooth-barked Apple - Red Bloodwood open forest (PCT 1776) with shrub layer dominated by exotic shrubs *Ligustrum sinense* and *Lantana camara*.

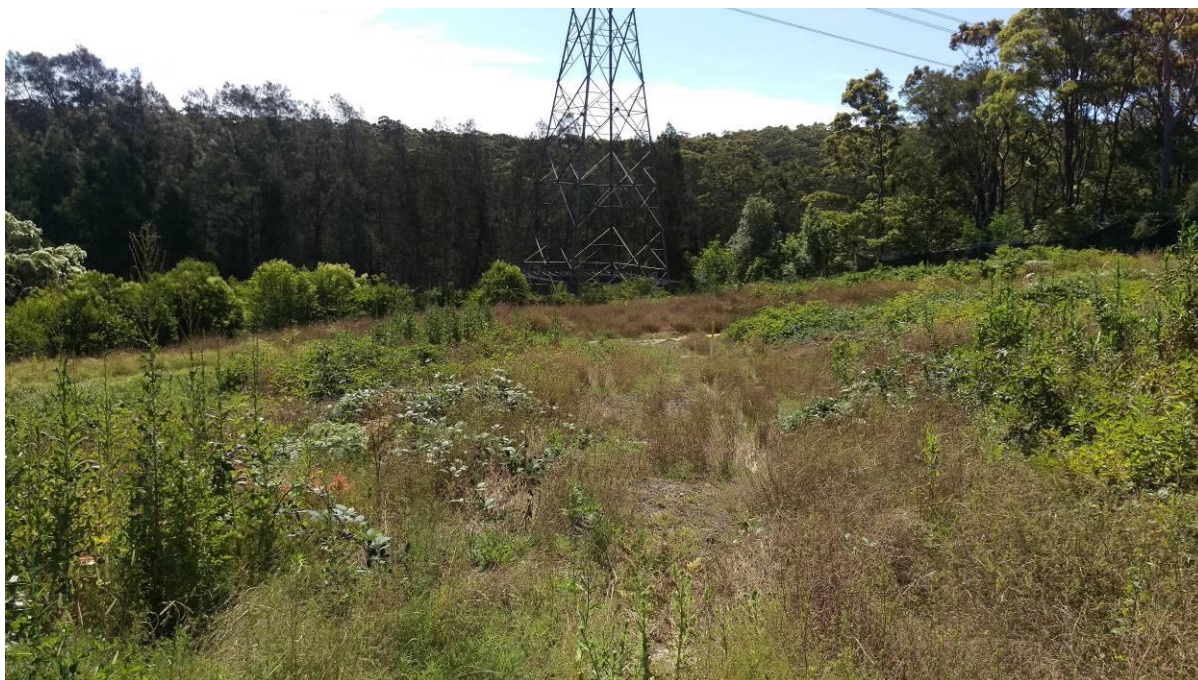
Photo 4 – Disturbed land / exotics in the south-west of the site looking south-west.

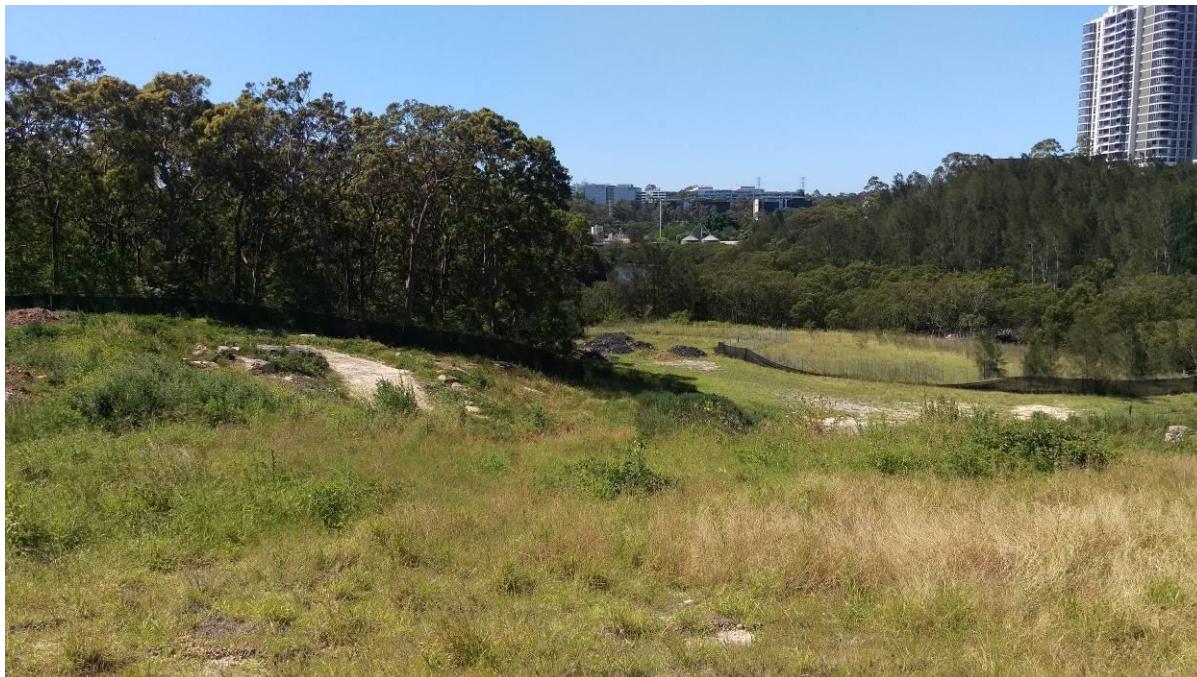
Photo 6 – Disturbed land / exotics in the centre of the site looking north.

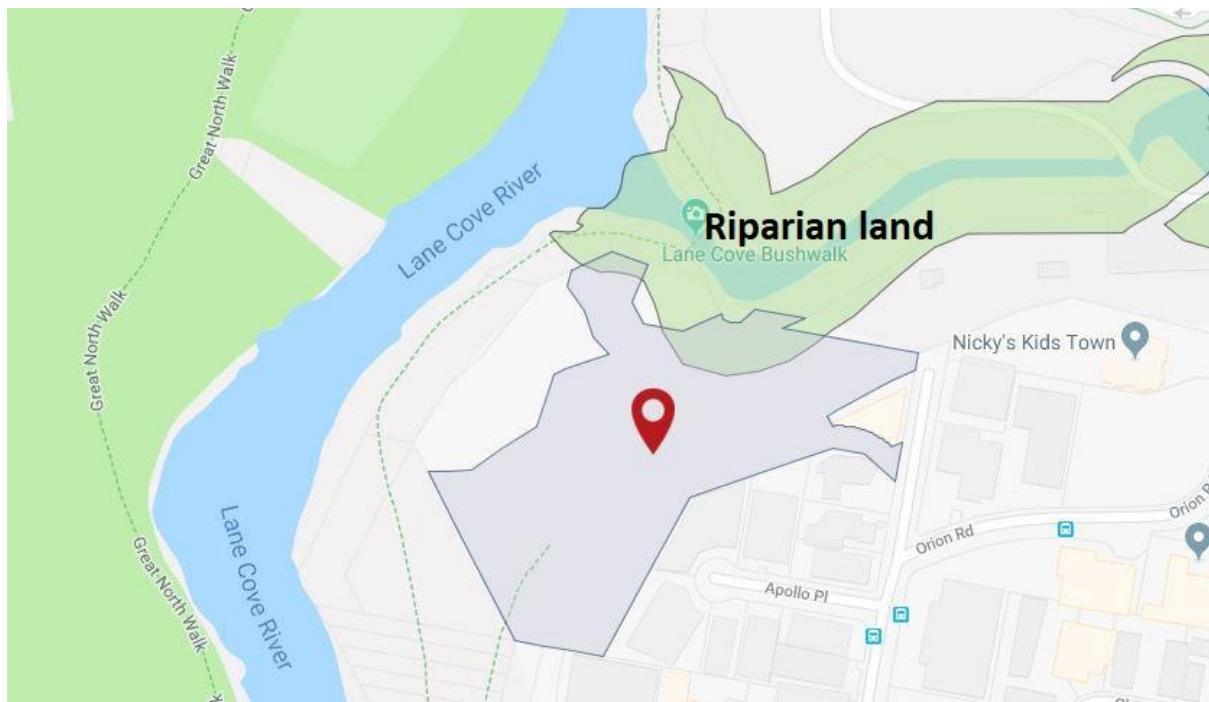
Figure 3 – Riparian land mapping (Lane Cove LEP mapping 2009)

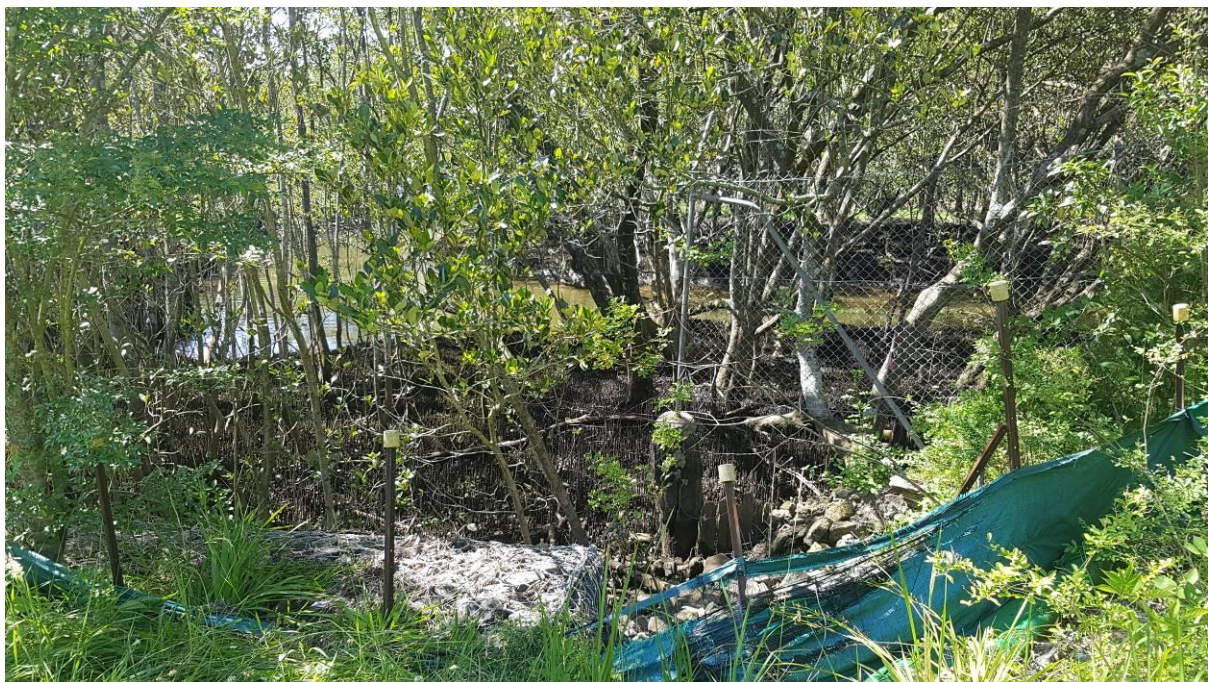
Photo 7 – Edge of Stringybark Creek just outside the northern boundary of the lot.

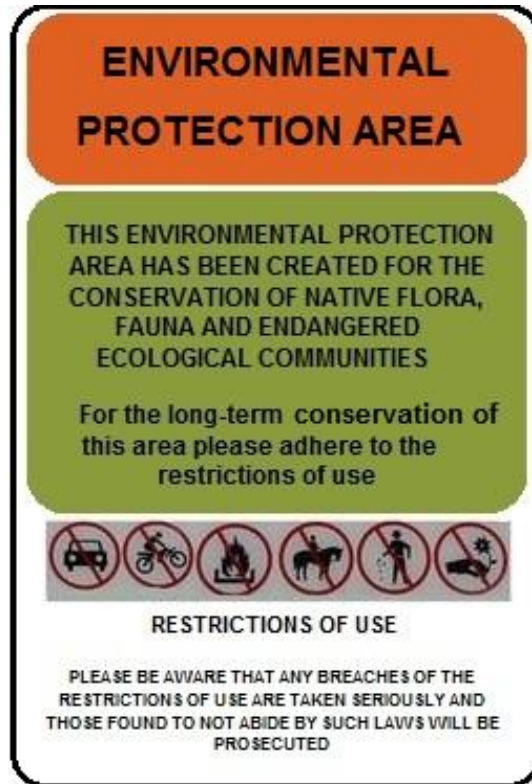
Figure 5 – Signage example

Signage is to be placed every 50m on the permanent fence around the edge of the restoration areas. This signage is to advise that the area is undergoing bushland rehabilitation works. An example of what may be suitable is provided in Figure 5.

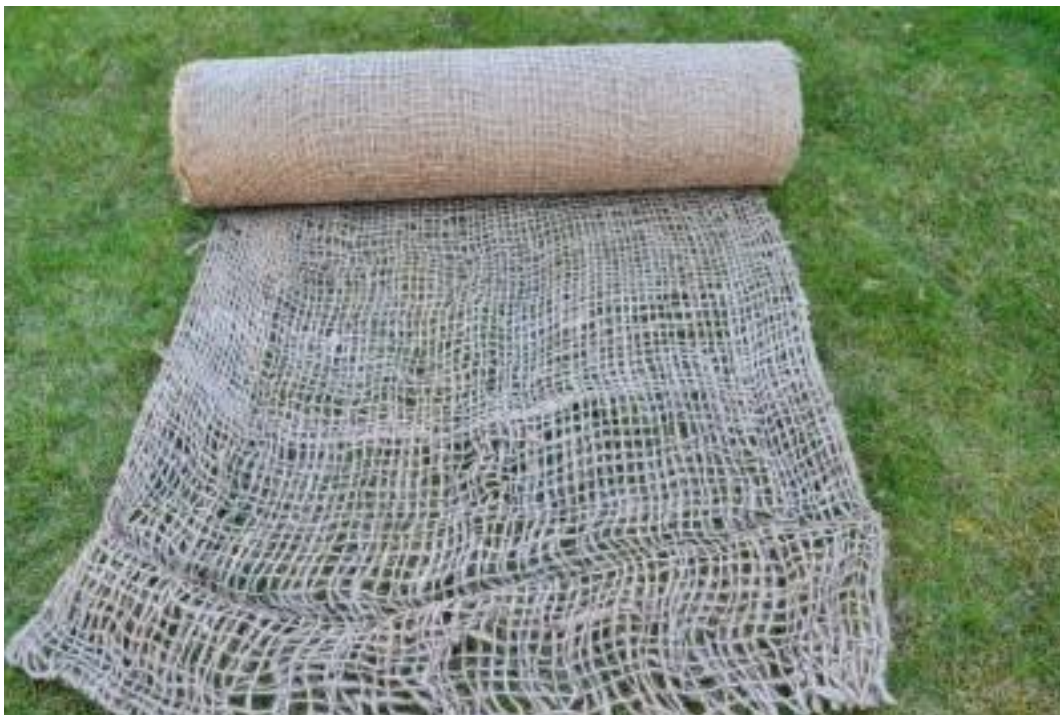
Figure 6 – Example of open weave jute mesh

To protect waterways, loose mulch should not be placed within 10m of the top of bank. Mulch under a covering of biodegradable erosion protection, such as pegged and overlapped open-weave jute mesh, is to be used for revegetation areas within 10m of the top of bank (see Figures 6 and 7).

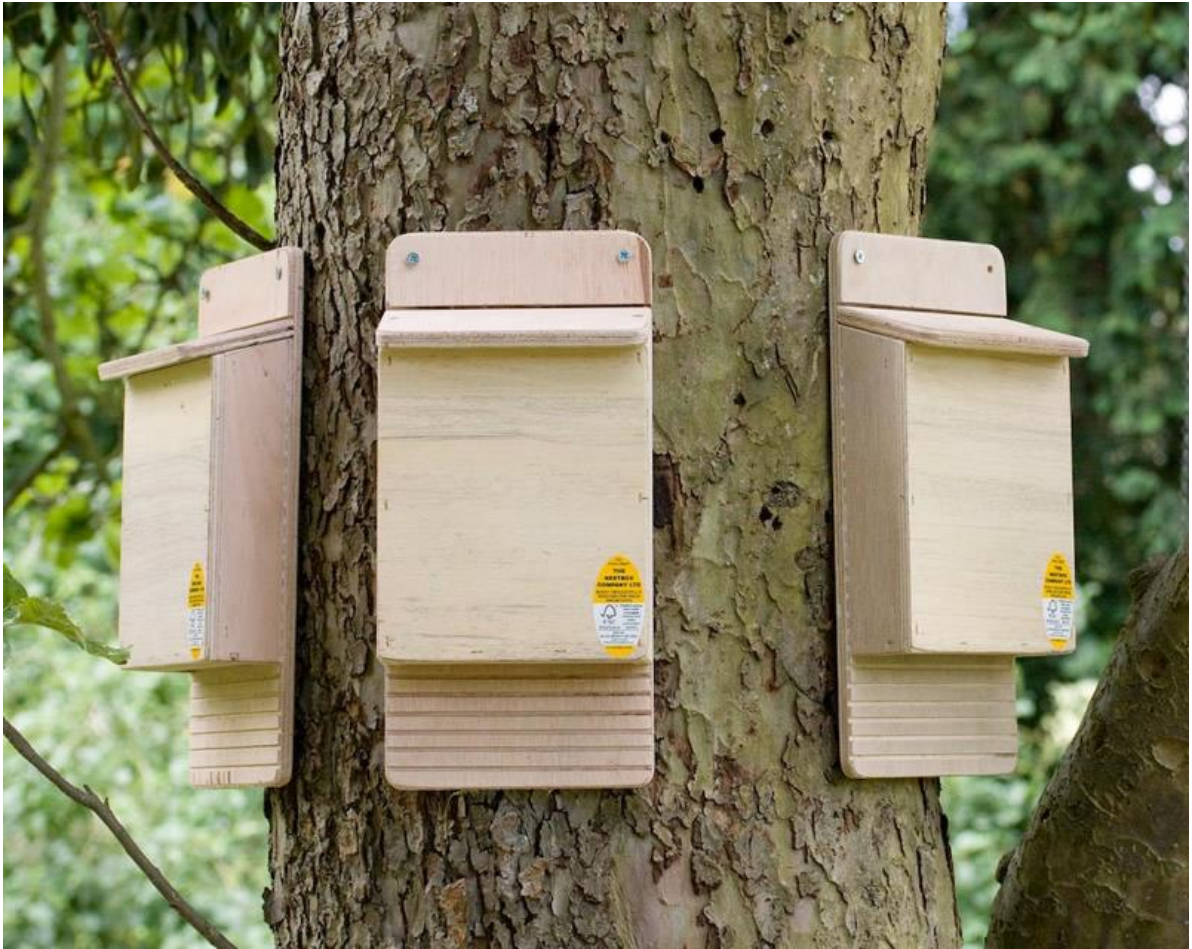
Photo 1 - Example of microbat design. Note: these boxes are not painted or appropriately affixed to the tree.
